LANCE INDUSTRIES CUSTOM TOOLS SINCE 1971

Standard Sockets:

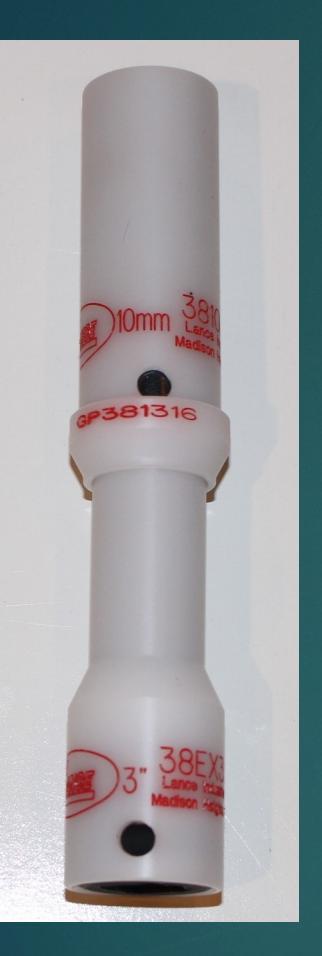
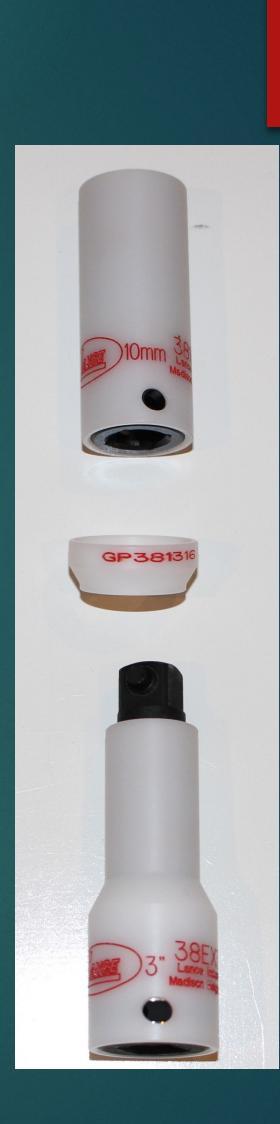
Extensions available in all standard drive sizes (male and female) and lengths.

Sockets: available in all standard drive sizes, hex sizes (metric and standard) and hex formations (standard hex, 12 point hex, surface drive and torx)

Gap protector placed between socket and extension (shown in image) eliminates the pinch point between the socket and the extension.

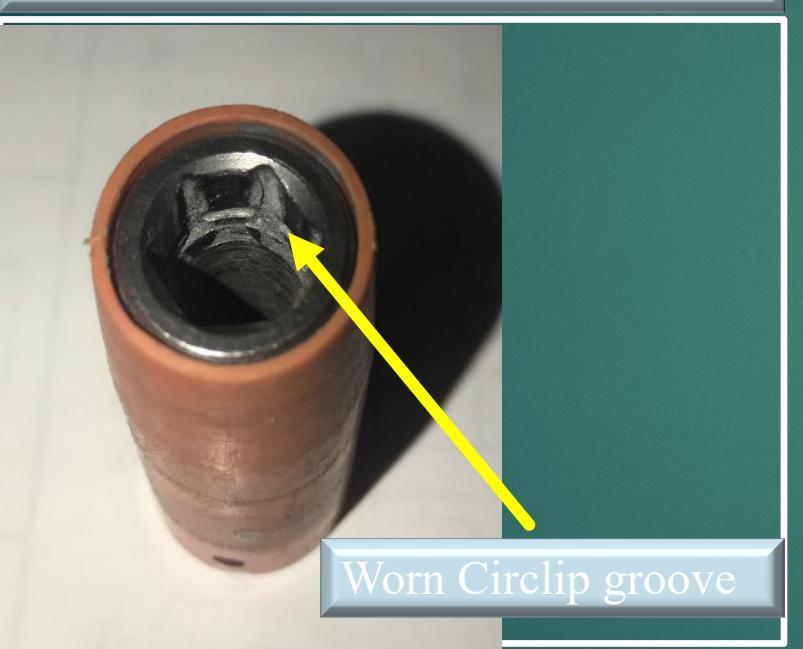
PLAN Understand the Problem

Description of sketch to explain defect. As can be seen in the above photograph, the sockets are easily worn and ran to fail

Production Technicians are tasked to replace the sockets being used to secure the fasteners in their respective areas. The sockets that are currently being floated in tool stores are clearly creating this phenomena. Most technicians prefer the spring loaded magnets that come with the APEX MB socket line. However, when the circlip wears, the sockets usually pop out and the magnet comes out as well. As a result, the technicians replace them instead of repairing them, and this replacement comes at a high frequency by chart provided.

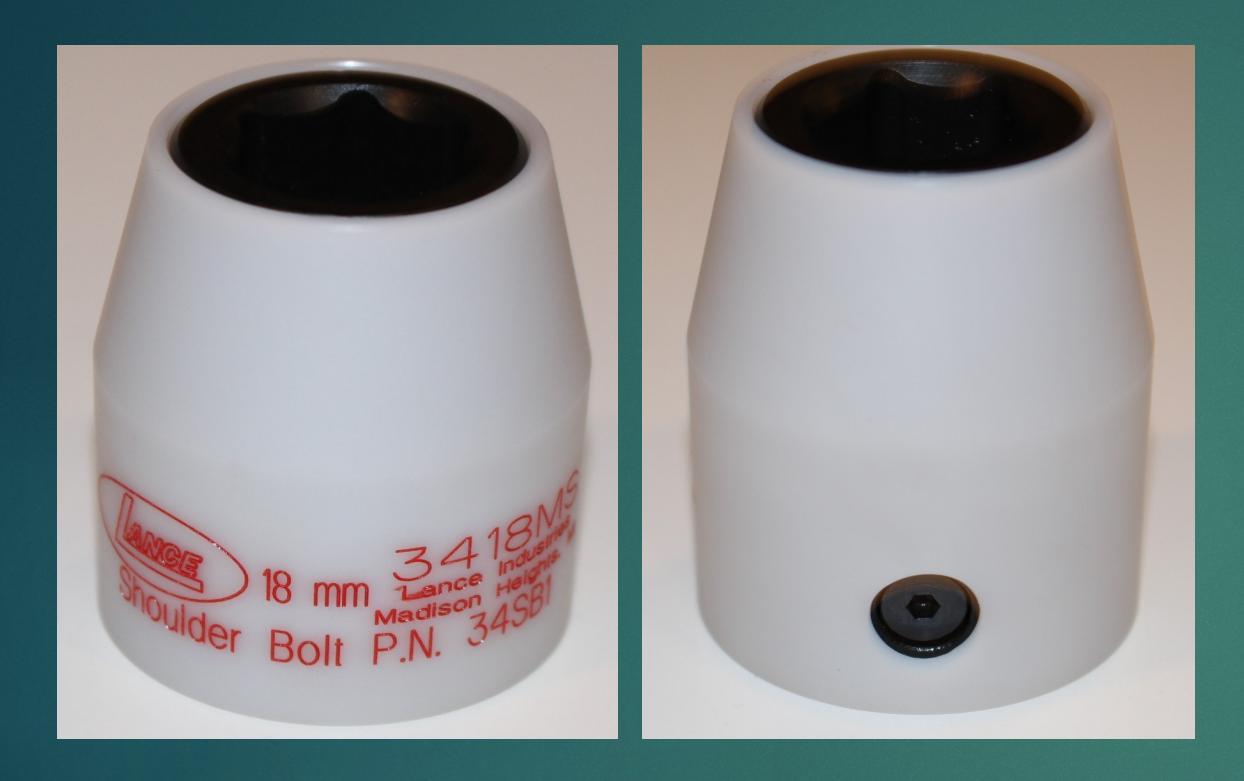
³/₄" Square Drive Covered Socket

- By using a shoulder bolt for a "pin" we have eliminated the need for an O-Ring on the socket
- Allowing for much easier removal all while maintaining the covered socket.

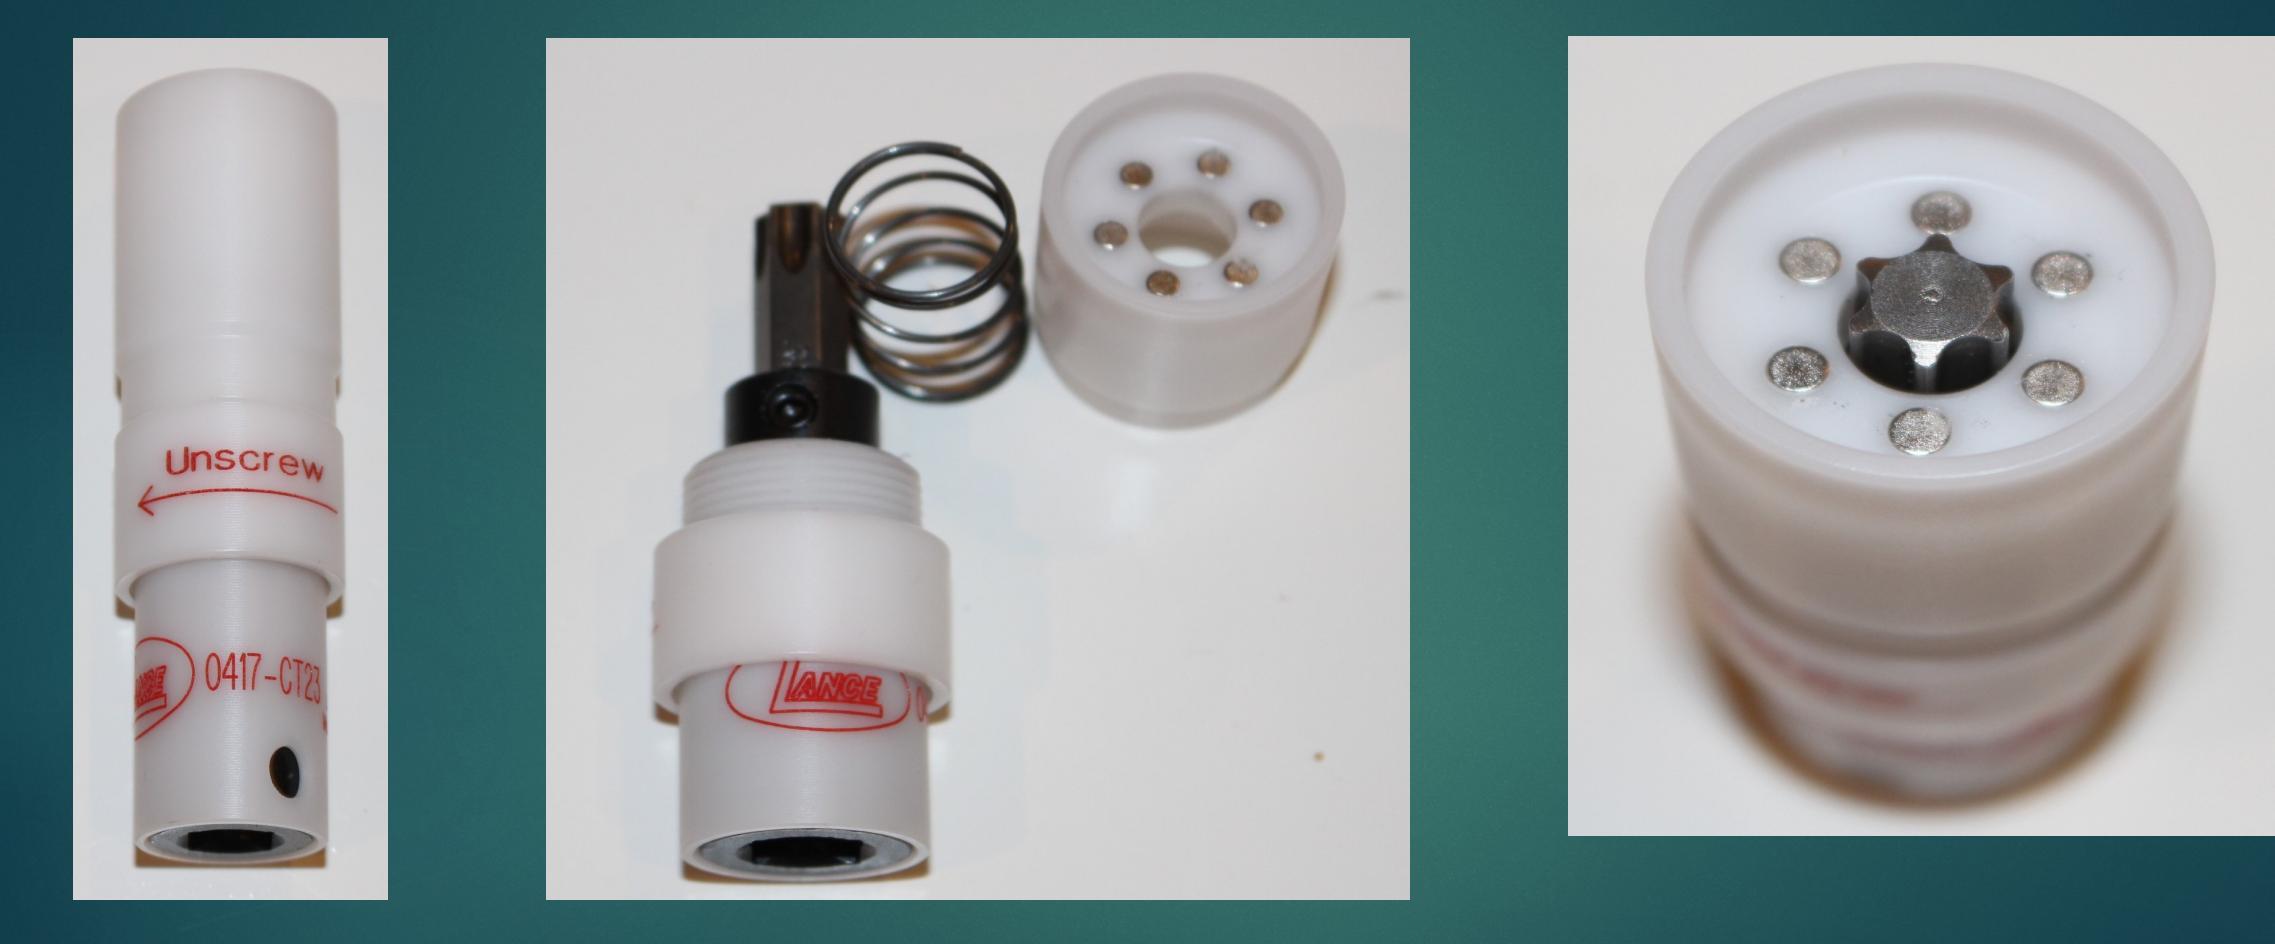
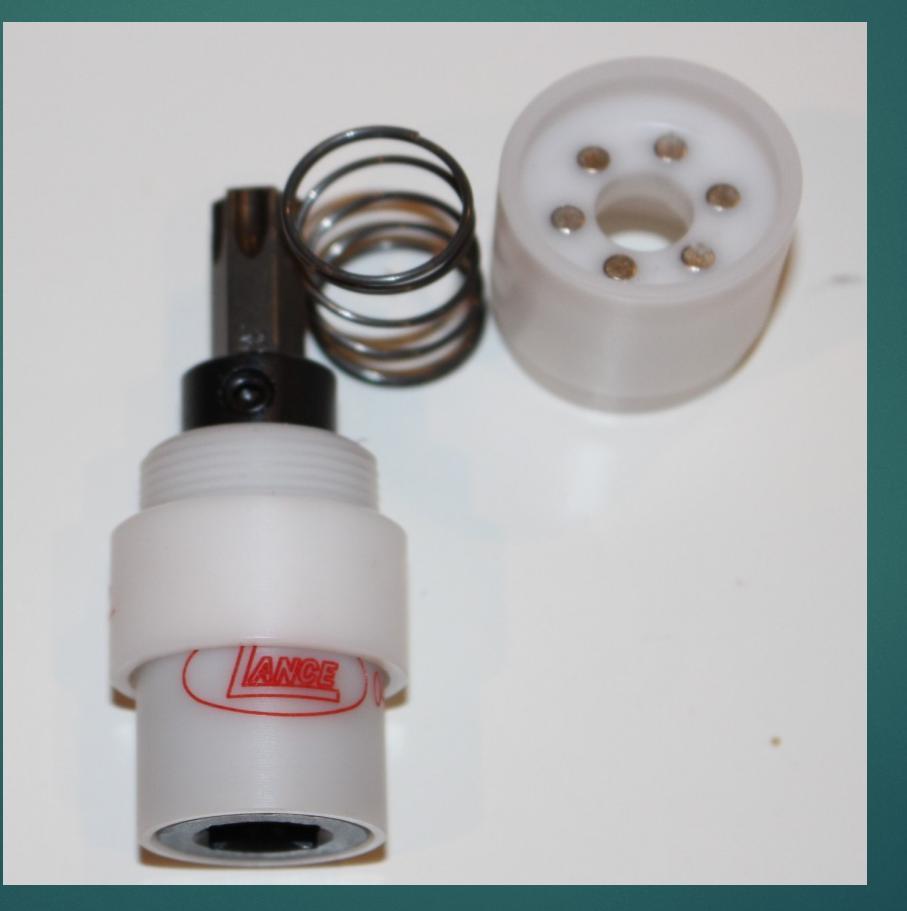
Magnetic Bit Holders

- Bit is recessed into the machined Delrin cap ELIMINATING and In-system-damage.
- Cap retracts to allow for full engagement of bit into fastener.
- Modular design to allow for all components to be easily interchangeable.
- Magnets completely hold fastener into place allowing operator to keep hands clear of any rotating parts.

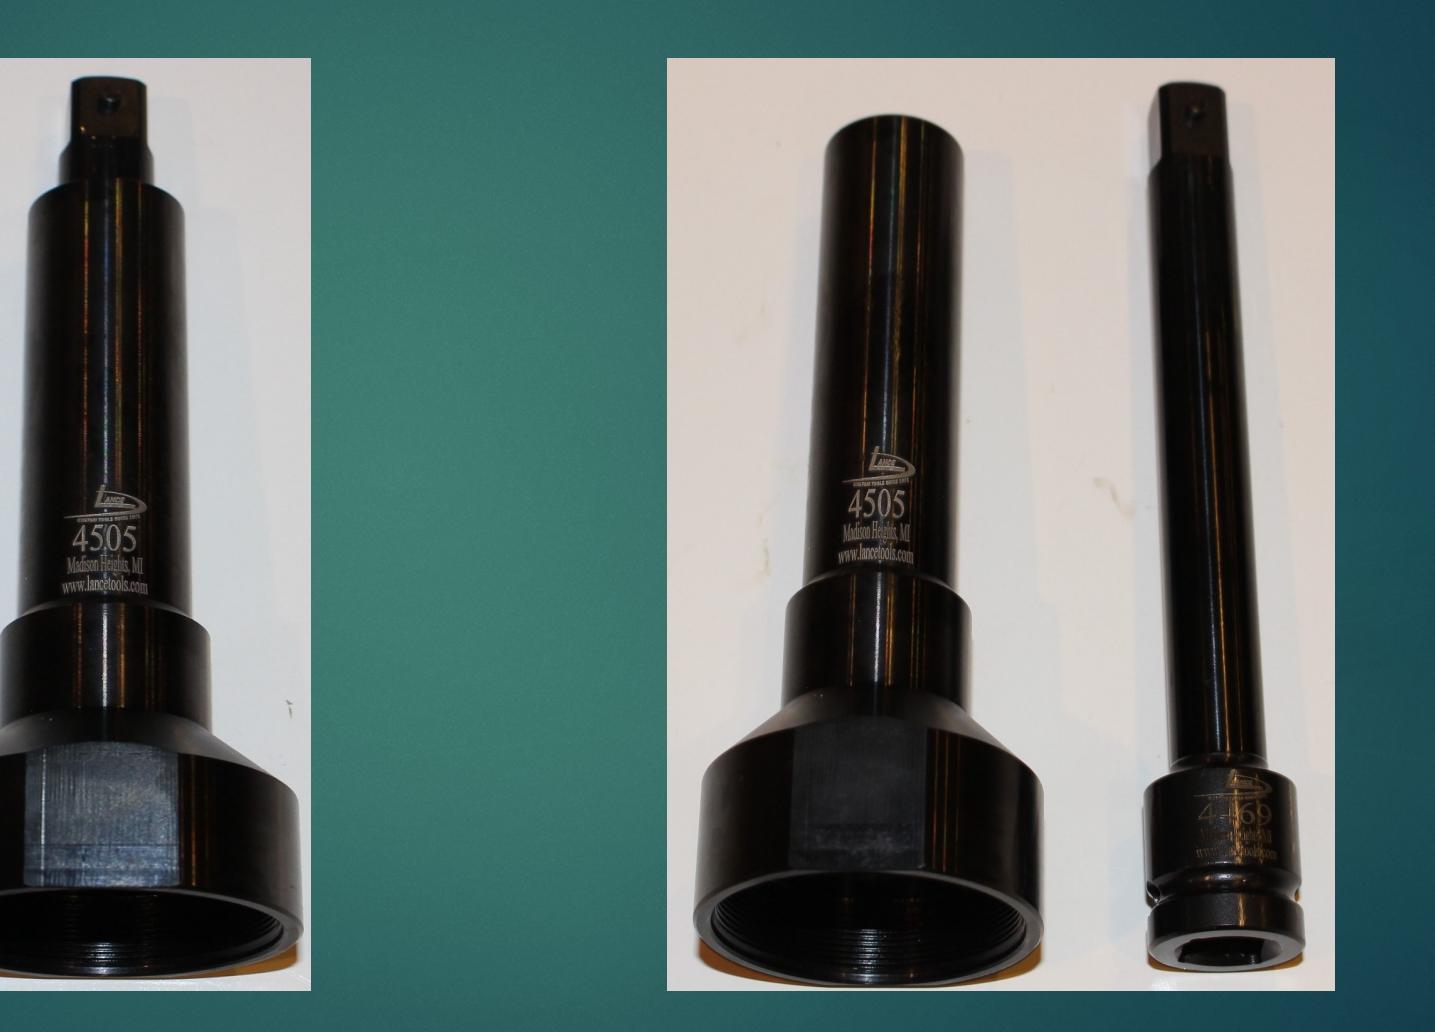
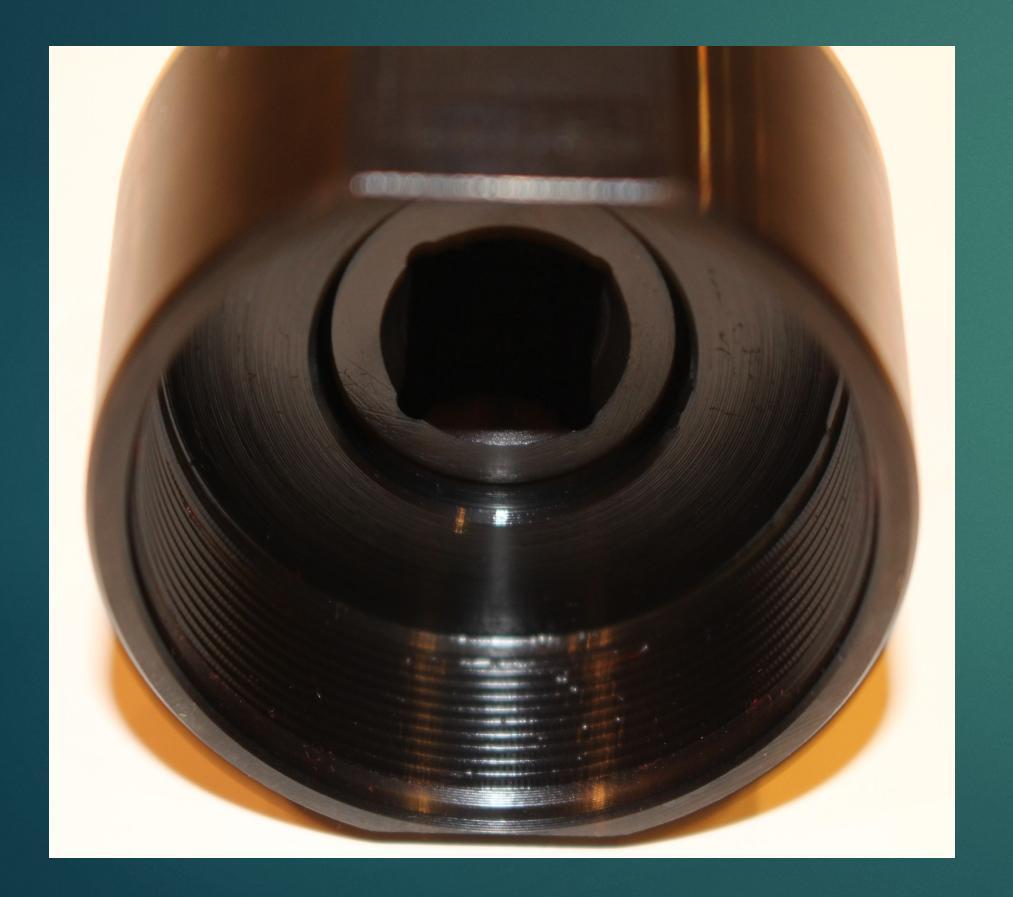
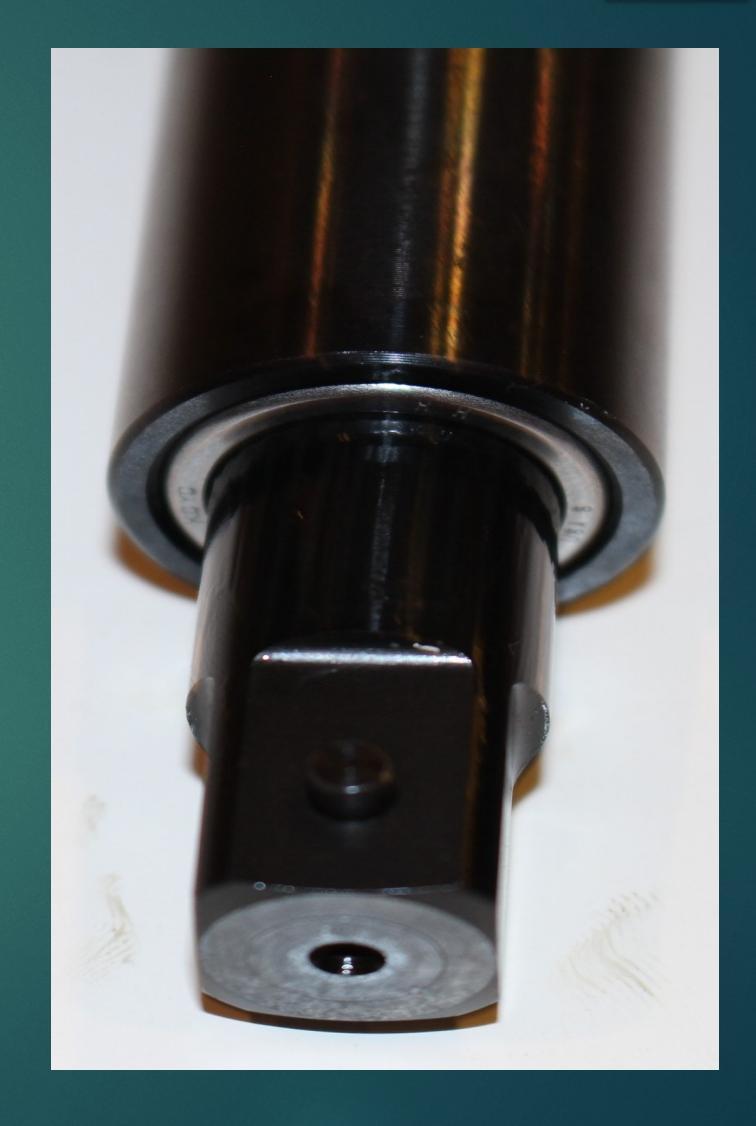
Guided Anti-Wobble Extensions

- Threads directly onto the nut-runner angle head.
- Eliminates any lateral-runout.
- Increases the longevity of angle head
- Ideal for applications with extensions over 8" long.
